Guide for School Facility Condition Surveys

ABC ELEMENTARY MECHANICAL CONDITION SURVEY

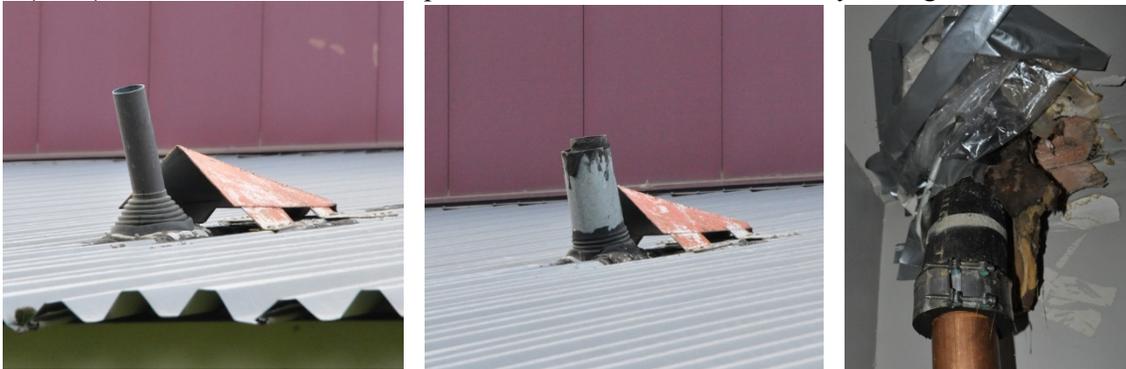
The sanitary waste piping and venting was not generally visible for inspection with the exception of short runs within the mechanical room. However, there was no ancillary evidence that the waste and vent piping was not performing adequately except as noted below. There are two plumbing vent through roof (VTR) extensions on the north sloped roof that have been bent over by sliding snow.

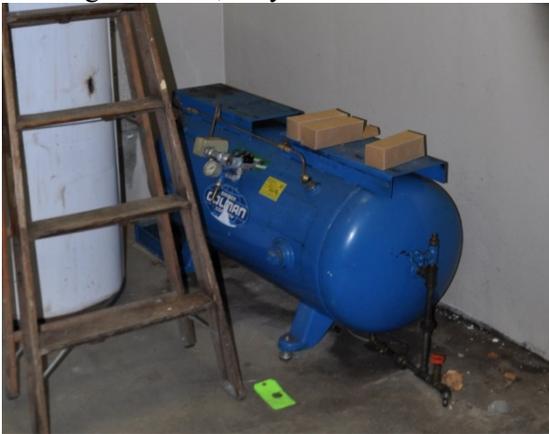
Mechanical controls installed in the original construction (a pneumatic system) are in disrepair, all are non-functional due to the absence of head end equipment (i.e., the compressor). The operating system and main controllers of this system are suspect even if the system was charged and pressurized and should be replaced or upgraded. In addition, approximately 40% of the room temperature sensors on the west side of the facility are missing. The remaining room temperature sensors indicated a reasonably accurate room temperature. The control air compressor storage tank in Mechanical room was not in working condition; only the tank remains.
